# Manhole Inspection Summary

Manhole # S07MM1027MH

Insp Date: **7/29/08 3:22 PM**

**Location** Address: **4913 LITCHFIELD AVE** Cross Street: **GARRISON AVE**

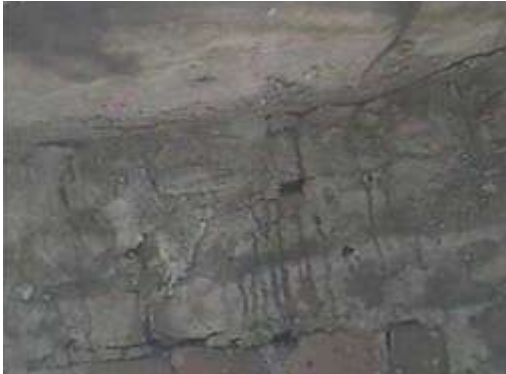
Defect 1

Condition: ☐ Sound ☒ **Cracked** ☐ Root Intrusion ☐ Loose Brick ☐ Deteriorated

CRACKED BARREL

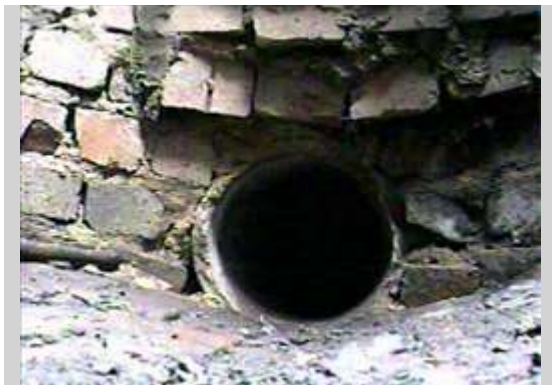
12 O'Clock Outflow

8 in. Circular Gravity Sewer  
Pipe Out @ 12 O'Clock

Infiltration: **None** Pipe Seal Cond: **Sound**
